TREC REI 7-6

1234 Main Street  
Hutto TX 78634

# PROPERTY INSPECTION REPORT FORM

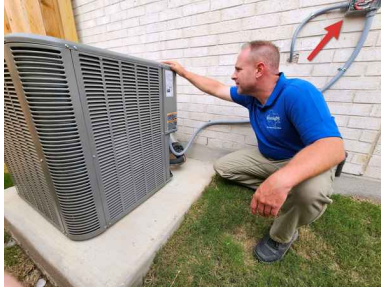
**1: AC Compressor disconnect exposed to the elements**

Exposed electrical connections pose as potential electrical shock issue.

Recommendation: Contact a qualified electrical contractor.

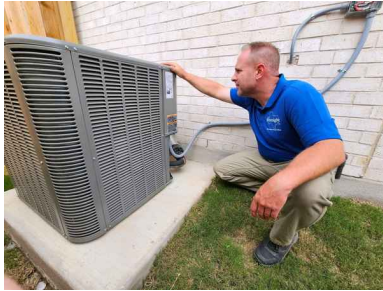
- ☒ ☐ ☐ ☐ **B. Cooling Equipment**  
*Type of Systems:* Electric -  
Lennox 3.5 ton 18 SEER

- Comments:*  
- Lennox 3.5 ton 18 SEER

- Compressor disconnect has been left exposed.
